Greatest Fire Risk often Out of Sight

Here, Richard Norman, Managing Director of Indepth Hygiene Services explains why it is important for those responsible for the safety of pupils and staff to give extract ventilation systems the priority attention they require.

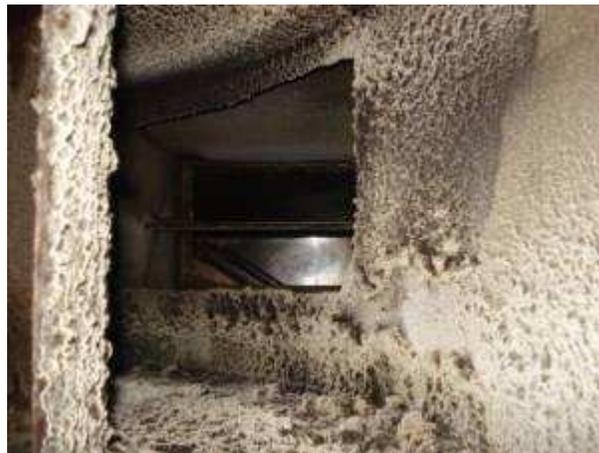
Internal ducting surfaces of a grease extract system showing uncleaned potentially flammable grease deposits

As I have explained, grease extract systems are often not given the attention they demand because extract ducting from the kitchen canopy often runs hidden behind ceilings and walls. Until a fire occurs, there are often seldom other clear signs of danger, although canopy filters which appear clogged can be a sign of hidden dangers in the ducting beyond. For the system to be made safe, access has to be gained at regular intervals into the ducting so thorough end to end cleaning can be carried out. It is totally inadequate for just the ducting to be cleaned as reachable from the filter housings. The total system must be cleaned.

Perhaps more worryingly, the owners thought they had in place a cleaning service to remove the flammable grease deposits in the extract ducting. Forensic inspection of debris after the fire showed clearly the ducting was not being cleaned. If access panels had not been cut into the ducting to provide access for thorough cleaning, you can be sure the internal duct surfaces have not been cleaned of flammable grease deposits.

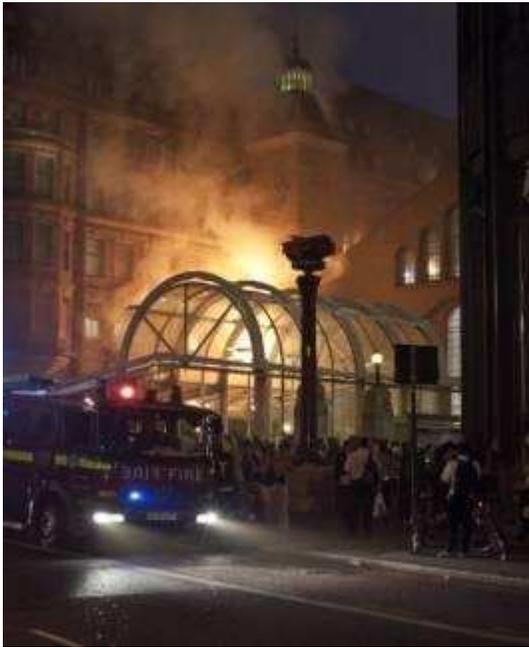
Fire in Extract Ducting at London Restaurant

A fire at Liverpool Street Station's Burger King Restaurant in June, where according to a London Fire Brigade spokesman, an uncleaned kitchen ventilation shaft in the restaurant had caught fire demonstrates clearly how widespread and dangerous such fires can be.

This is yet another example which clearly demonstrates that grease deposits in inadequately cleaned ducts can lead to substantial fires. On this occasion, thankfully, no one was hurt. However, if premises managers fail to have internal cleaning of their extract ductwork carried out, the chances of serious fires remain a potential threat.
