Coming clean

Warning of the dangers posed by unclean grease extract systems in commercial kitchens, **Richard Norman** argues for better management of the risks and more effective inspections by regulatory agencies

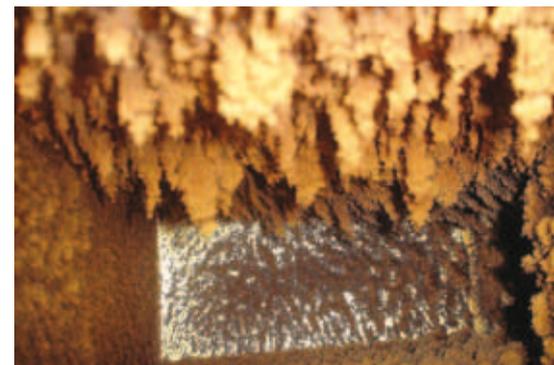
Grease deposits can be easily ignited if allowed to build up in the extract system

A kitchen extract ventilation system draws grease-laden air directly from the areas above cookers, grills and fryers via the cooker hood, and discharges it into the atmosphere. These grease deposits are easily ignited by even a small flash fire on or in the fryer, hob or grill. Flames and heat can then quickly spread through the building, causing substantial damage and endangering the lives of diners and staff. And, with many restaurants situated beneath

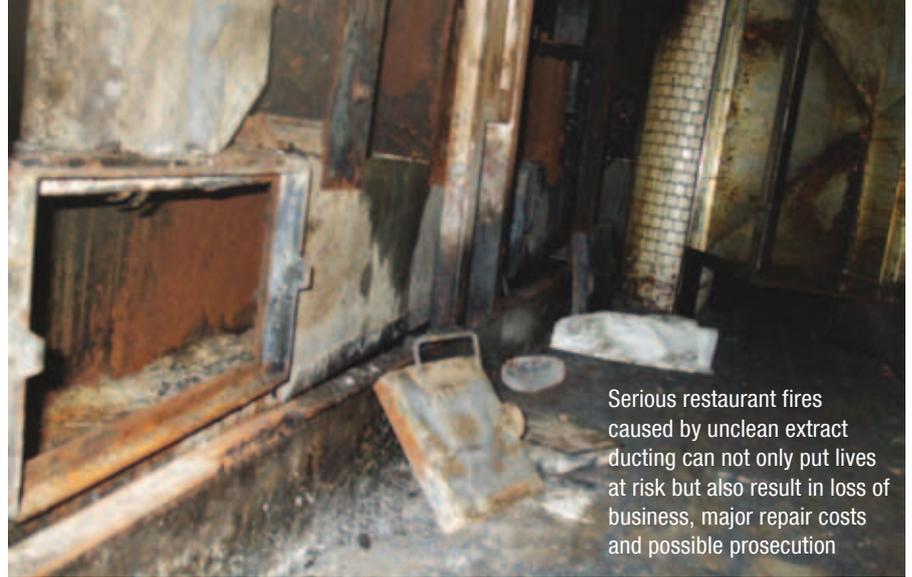
Serious restaurant fires caused by unclean extract ducting can not only put lives at risk but also result in loss of business, major repair costs and possible prosecution
